CENTRAL INTELLIGENCE AGENCY

COUNTRY USSR (Arctic)

SUBJECT Kola Bay

DATE DISTR. 17 March 1955

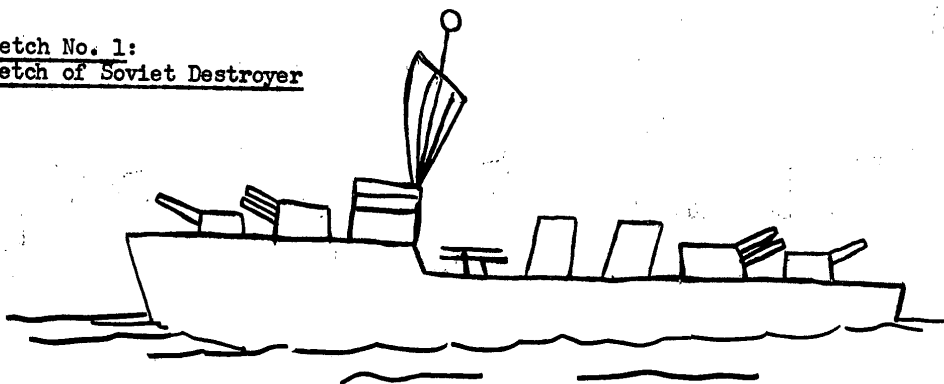
Sketch No. 1:
Sketch of Soviet Destroyer

- b. Six to eight destroyers, each 90 to 100 meters long. There were two
gun turrets on the foredeck with one gun in the first and two in the
second. There was a mast just aft of the bridge, and there was a round
object on top of the mast. There were two stacks, and the stern was
square. On the afterdeck there were two turrets with two guns in the
first and one in the second. (See photo No. 2)

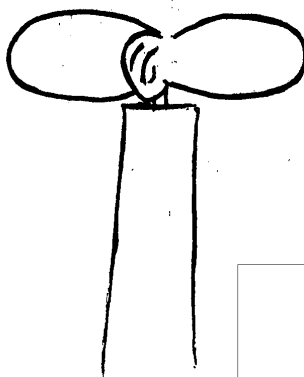
Sketch No. 2:
Sketch of Radar Installation:

4. North of Vayenga Bay, either on Hill 405 or on the hill at Stolkovyy Point (N 69-07, E 33-26), a radar station. It consisted of a framework about 15 meters high bearing an object resembling a four-bladed propeller. The blades were oval cup-shaped screens about five meters high and slightly longer. The screen was vertical. (See sketch No. 2 on page 2.) The propeller turned slowly, probably making one revolution every one and one-half to two seconds. 25X1
